City of Goodyear
PEDESTRIAN BRIDGE
Pedestrian Assessment

From:
INCA ENGINEERS
A DYE DESIGN

October 21, 2004

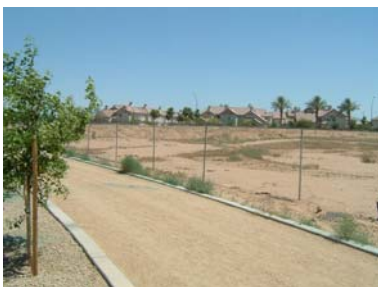
Existing Multiuse Path and Nearby Residential

Physical Assessment. The multiuse path is 11' wide, constructed of stabilized decomposed granite, with landscape, and connects bicyclists and walkers throughout the cities of Avondale and Goodyear. It is owned by Goodyear.

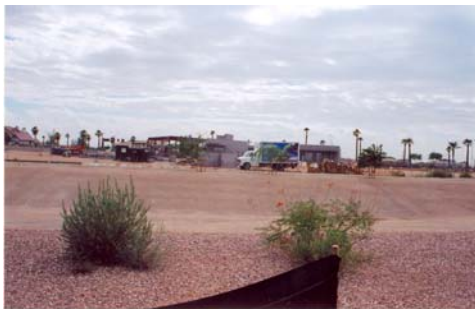
Looking from Church Parking Across Channel to YMCA

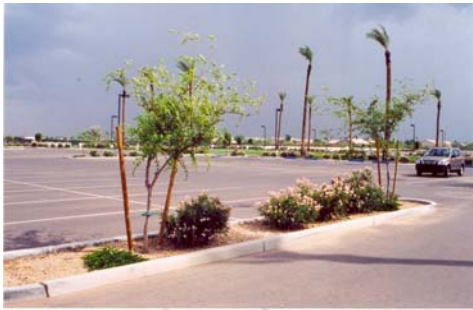
Existing Church Parking Lot

Finding: none of the above traffic calming techniques is necessary due to low volume and slow traffic.

Finding: This may be needed across the parking lot at the Church.

Recommendation: additional queuing area at the bridge/Church parking lot is necessary.

Recommendation: At a minimum, striped walkway is needed. A preferable solution is to build up a curbed walkway.

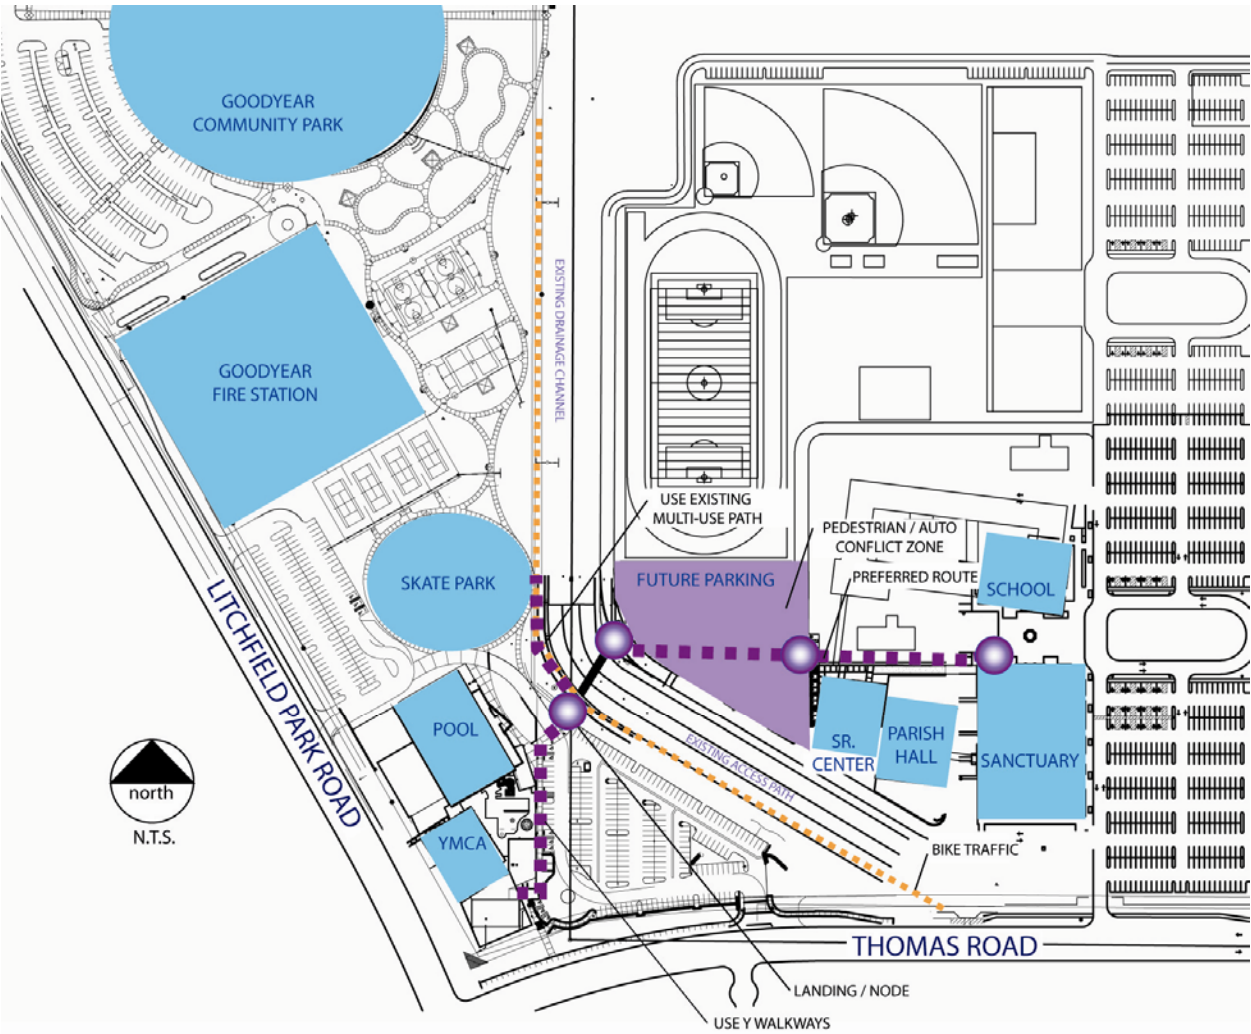
Figure 3 – Recommendations

The plan summary of recommendations is shown in Figure 3 on the next page.

Recommendation: Design the linking path from the Church courtyard through the parking lot at a minimum of 6' wide (preference is 10') with no obstructions.

Widen the walkways at the YMCA between the bridge and pool to 10'.

Recommendation: Provide concentrated areas of shade where feasible (park, YMCA walkway, at several locations on the Church parking lot, and at the multiuse path), that equal 50% along the entire path.

Recommendation: provide lighting at the bridge and along the multiuse path from the bridge to the park.
